# Mariners' Alerting and Reporting Scheme

MARS Report No 357 July 2022

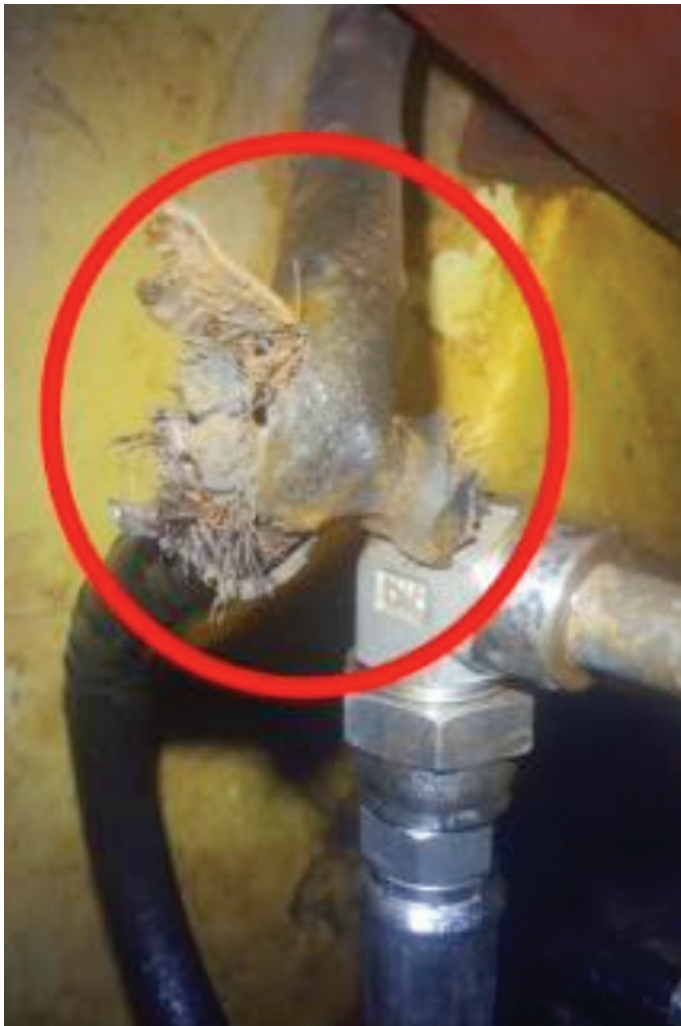
→ A deck officer was tasked to escort an accredited technician to inspect the free fall lifeboat air cylinders while the vessel was in port. The technician requested that the officer assist him by opening the air cylinder valves one by one to check the pressure. The first valve was opened without incident but when the second valve was opened, the high-pressure hose burst near the officer's face. Compressed air, dust and particles from the damaged hose hit his eyes, causing irritation.

This incident is a good example of why protective eyewear should be in common use on board, much as hard hats and steel-toed boots already are.

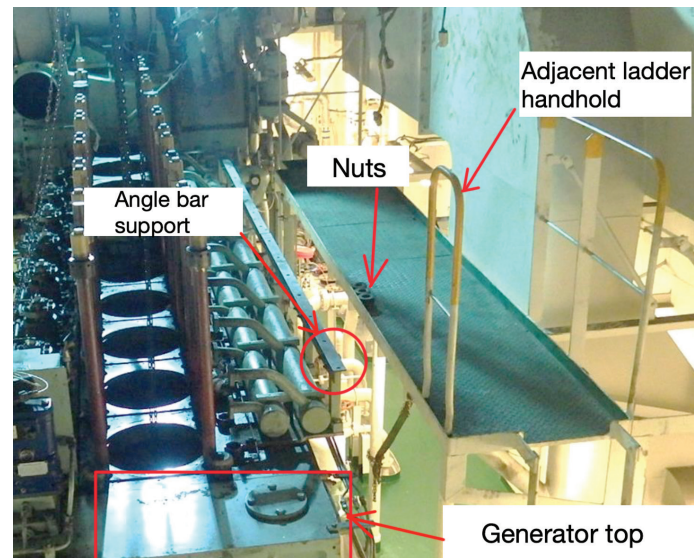
As the work progressed, one of the engineers was standing on top of the generator. There was a walking platform adjacent to the generator top, at the same height but separated by a gap of 40 cm. The engineer required some nuts that were lying on the platform, but were out of his reach. He attempted to step onto the platform from the top of the generator. He steadied himself with his right hand on the adjacent ladder handhold and stepped onto the platform with his right foot. As he brought his left leg forward he slipped. His leg struck the edge of an angle bar supporting the exhaust manifold with some force.

The blow resulted in a cut 15 cm long and 3 to 5 cm deep on the calf of his left leg. He was given first aid and later disembarked for shore treatment. He was declared fit for work about three weeks later.

- We are often tempted to overreach when accomplishing a job. Better to have help.
- Proper PPE is important. In this case, the engineer was wearing only a light cloth coverall. It is likely a more robust coverall would have afforded better protection.
- Permits to work and workplace inspections before beginning work are good risk reduction measures but they cannot remove all risks. Careful attention to our actions and common sense are needed throughout the task.

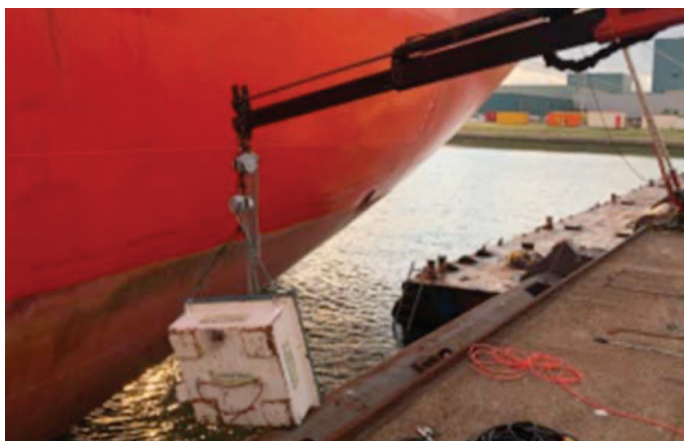
Once the cofferdam had been installed, repairs started with the removal of the pipe inside the engine room. The new pipe was then fitted and partially welded to the hull. The first welding pass covered approximately 50% of the pipe circumference. The inboard flange on the new overboard pipe was tag-welded. As a new work crew came in a leak was discovered. Immediately the divers, still in the water, were informed and they attempted to close the leak at the cofferdam.

The investigation revealed that heat from welding could have caused deformation of the ship's side plating, causing the cofferdam to lose watertight integrity. Also, the flat cofferdam did not form a perfect seal with the hull due to a slight curvature at that location.

Cofferdam being positioned

- The task was executed by an external team, resulting in limited crew participation. Close coordination and supervision of contractors by crew provides an added layer of safety.
- In an emergency, pumping bilge water and ballast directly overboard is allowed within MARPOL and the International Convention for the Control and Management of Ships' Ballast Water and Sediments.

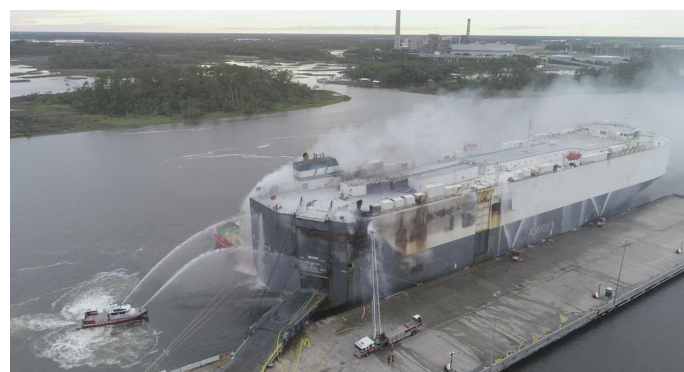
the crew were securing vehicle ramps, the chief mate noticed smoke coming from a ventilation housing for one of the exhaust trunks. Upon further investigation, crewmembers discovered a fire on deck 8, which was one of those that had been loaded with used vehicles.

The CO<sub>2</sub> was ineffective for a number of reasons; not least that the dampers for decks 7/8 were ineffective or not adequately secured. This gave the fire continued access to oxygen, negating the effectiveness of the CO<sub>2</sub>. The fire continued to spread to higher decks and the accommodation. Shoreside firefighters entered cargo decks with fire hoses in an attempt to douse the flames. Suddenly, an explosion occurred and nine firefighters were injured, five of them seriously. Responders subsequently adopted a defensive strategy, cooling external exposed surfaces. The fire was finally extinguished eight days later.

The fire was likely caused by an electrical arc or component fault in one of the vehicles. The company's established vehicle loading and battery securement procedures call for a properly disconnected and secured battery for all vehicles loaded on the vessel. These procedures were not followed by the longshoremen preparing and loading vehicles onto the car carrier. Neither vessel crew nor shore supervisory personnel corrected this deviation.

- As with most accidents, there must be a failure of several layers of the safety regime for there to be negative consequences. In this case these failures were both ashore and on board.
- Procedures are meant to be an administrative barrier to negative consequences. They should not only describe the hazards but provide the process by which the hazards are actually mitigated.
- Extinction of a fire using a fixed extinguishing system such as CO<sub>2</sub> relies on two conditions:
  - 1) Timely release of the extinguishing agent before the fire can spread elsewhere on the vessel
  - 2) The securing of vents and ventilation so that the extinguishing agent can be effective and air cannot continue to feed the fire.

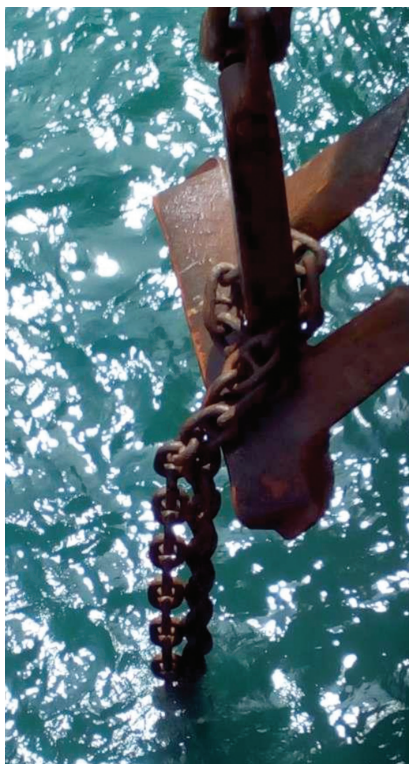
The port anchor chain was then heaved up. It was found that the anchor was not, in fact, lost; the bitter end had remained secured. However, when the port anchor was heaved up, it could not be secured because it had become entangled with the starboard anchor chain.

The company investigation found that the port anchor brake was not working properly; it did not move before the brake reached the 90% open position. If the equipment had been in good condition, the anchor chain could have been controlled.

- Anchor brake maintenance is a crucial element in safe operations. The uncontrolled descent of an anchor chain can not only pose a significant risk of losing an anchor, but also poses a lethal hazard to crew.
- During and after an incident it is sometimes difficult to assess and communicate the state of affairs – yet this is what is needed for ships' leaders to make the right decisions going forward.

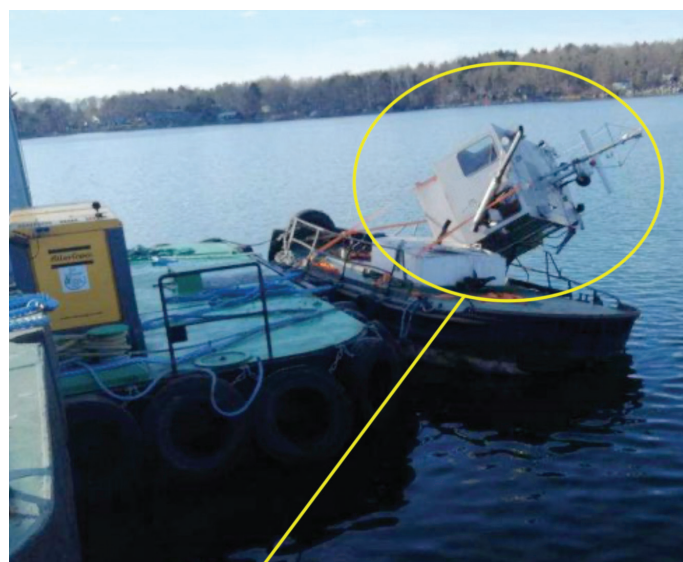
The vessel gained speed astern, and was closing on the dredging units. The officer on the quarter-deck warned the bridge team that the vessel was now 20 metres from the dredging units and continued to give the distances, which were closing quickly as the ro-ro was now making about two knots astern. At some point, full ahead was applied on the engine controls but the effect was too late. The stern of the ro-ro continued to sweep over the attending dredging tug. The tug wheelhouse was torn from its attachments, and was left hanging over the starboard side of the tug.

Tug wheelhouse torn from attachments

- Controlling a vessel that is moving in two directions (swinging and fore/aft movement) is harder than controlling a vessel that is moving in only one. The fact that the vessel was turning at the same time as it was reversing probably affected the bridge team's situational awareness.
